Nondestructive Testing of Aircraft and Spacecraft Wiring

by John E. White,* Edward J. Tucholski† and Robert E. Green, Jr.‡

ABSTRACT

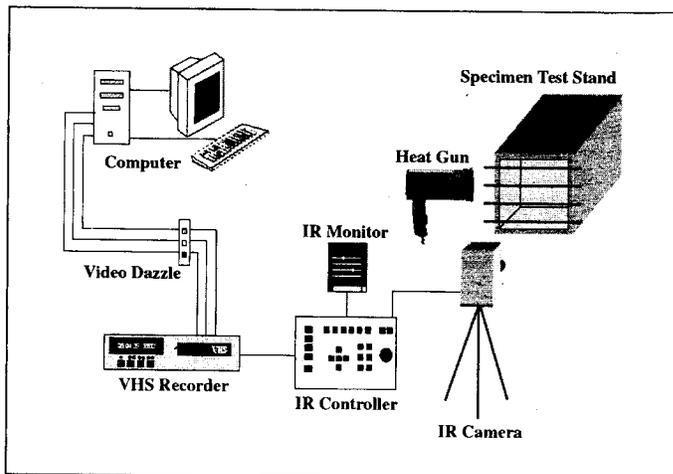
Figure 1 — Schematic of the infrared thermography system.

In the current research, a standard handheld heat gun was utilized to distribute heat over various lengths of single wires, multiple wires and wire bundles. Two infrared systems were used during this phase of the experimentation: a general commercial model and a newer, high resolution model. The testing was conducted on wires approximately 305 mm (12 in.) in length which were affixed across the opening of an insulated styrofoam box with an open face of 229 by 305 mm (9 by 12 in.). A schematic of the infrared thermography system used is shown in Figure 1.

The infrared camera was placed at a standoff distance of approximately 0.6 m (2 ft). The wires were then heated with hot air from a heat gun possessing a wide nozzle attachment to distribute an even heat flux across the surface of the wires while passing the hot air across the face of the box along the length of the wire samples. The advantage of this procedure was to ensure that all of the wires could be heated concurrently. At a minimum temperature sensitivity of approximately 283 K (18 °F), the baseline image with no heat applied yielded an image of light gray wires against a dark gray background. However, upon a single sweep of the heat gun, set at 593 K (600 °F), the radiant intensity of the wires was raised

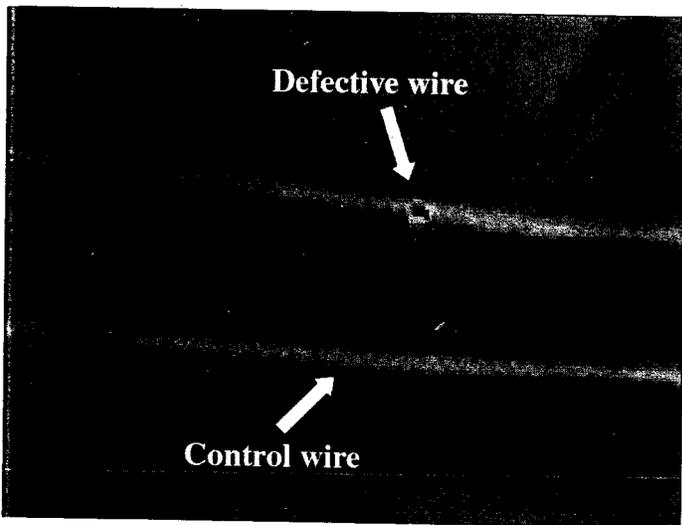
Figure 2 — Infrared thermography: single wire test.

Initially, to determine the effectiveness of the infrared thermography technique, an 18 gage wire with a minor fray was taped to the open face of the test box. Approximately 25 mm (1 in.) below, a second undamaged control 18 gage wire was affixed to the box, as shown in Figure 2. While heating with a heat gun, both wires visibly began to heat up and became easily visible when viewed with the standard infrared camera system. Most importantly, the region in the vicinity of the fray turned a different color (or different shade of gray), representing a higher temperature and making it much more visible than when tested visually. The control wire, having no such fray, remained uniform in temperature.

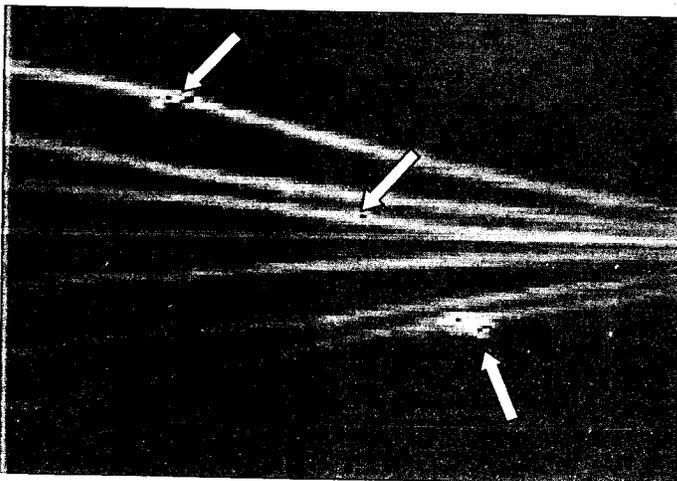
Figure 3 — Infrared thermography: multiple wire test.

A six wire test was performed to determine the relative sensitivity of this test to wires in close proximity containing various discontinuities. In this test, five 18 gage wires differing only in the magnitude, type and location of discontinuity were taped horizontally across the test box. A sixth wire was added as an experimental control. In Figure 3, the top wire was chafed with a knife, the second wire from the top was stripped of its outermost layer of insulation, the third wire suffered a subtle cut, the fourth wire was undamaged, the fifth wire had been crimped and suffered from resulting bend damage and the sixth wire was significantly frayed.

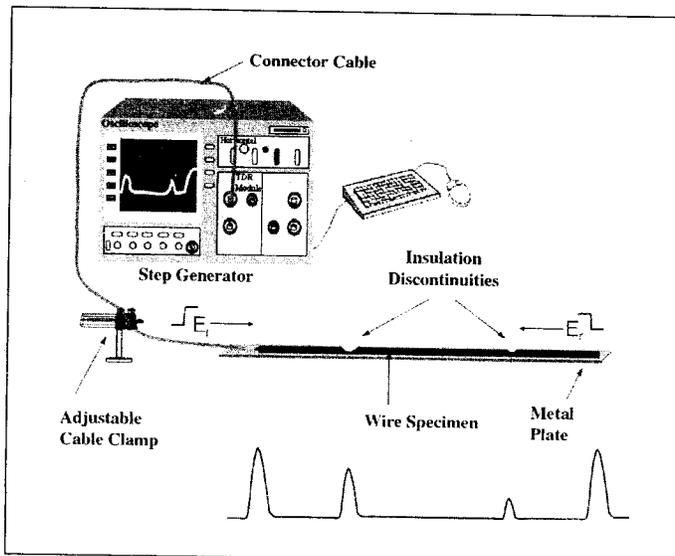
Figure 5 — Schematic of the time domain reflectivity system.

As shown in Figure 5, an electrical pulse is launched by the step generator at one end of the wire or cable and reflected from the opposite end. The time of propagation of the pulse from the propagation end and back from the opposite end is determined by the

length of the wire or cable and the speed of the signal traveling through the wire. If a discontinuity exists at an intermediate location, such as a break in the conductor or a significant change in dielectric loading of the insulation coating, which would cause a perturbation in electrical impedance, a reflection comes back to the oscilloscope before it should. Its arrival time tells the distance to the discontinuity and the magnitude of the returning pulse is related to the size of the discontinuity. When connecting the test wire, the inner conductor of the coaxial connector cable is attached to the conductor of the wire under test and the outer conductor is attached to the metal plate test stand to create a capacitive cell.

In Figure 5, the connection to the test wire, the discontinuities in the insulation and the end of the wire were described schematically as positive changes in impedance. In fact, the change in impedance is very likely to be negative if the discontinuity in the wire lowers its overall capacitance. As an example, Figure 6 shows the results of a metal shard embedded in the aromatic polyimide insulation of a braided conductor wire. The wire specimen is a 250 mm (10 in.) section of 18 gage wire. The metal does not penetrate through to the conductor, but its presence is easily detected on the time domain reflectometer as a reduction in impedance.

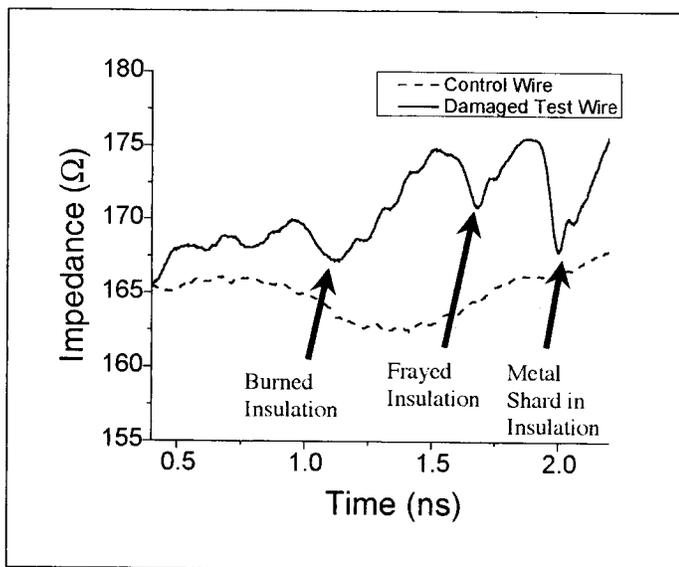
Figure 6 — Time domain reflectivity results of a metal object in wire insulation.

Other damage to the insulation can be detected due to the difference between the relative dielectric constant of air and the insulation. Nicks, scrapes, cuts, chafes and frays are then detectable by a trained operator using this technique. Figure 6 also demonstrates a noticeable change in the impedance in an area where the insulation was stuck with a pin multiple times until frayed. Also visible is a decrease in impedance where the wire insulation was burned with a soldering iron over an area of about 10 mm (0.4 in.) in length along the wire insulation surface.

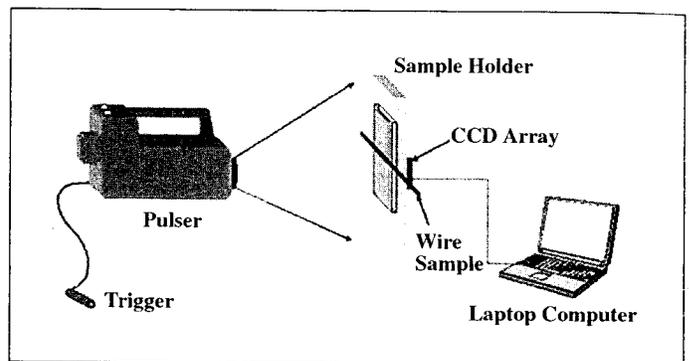
Figure 7 — Schematic of the pulsed X-radiography system (charge coupled device detection).

pulsed X-ray source. Either a film cassette or a charge coupled device flat panel, solid state array sensor with an active area of 36 mm by 26 mm (1.2 in. by 1.0 in.) coupled to a laptop computer was used for data acquisition and image display as illustrated in Figure 7. Use of the charge coupled device array method, however, enabled instantaneous imaging feedback and eliminated the costs and processing time associated with film development. The pulsed X-ray source had a fixed nominal energy of 150 kV, yet other pulsed X-ray sources are available ranging from 100 kV up to 2 MeV. High speed flash X-radiography can be performed using X-ray pulses having a duration of less than 100 ns. The spectrum from molybdenum or tungsten targets consists of a short wavelength component having substantial penetration and additionally a longer wavelength component, which permits enhancement of the image contrast. The pulsed X-rays were controlled by means of a remote electrical switch. The X-ray source is a pointed anode with an array of cathode wires arranged both circumferentially and longitudinally along its length.

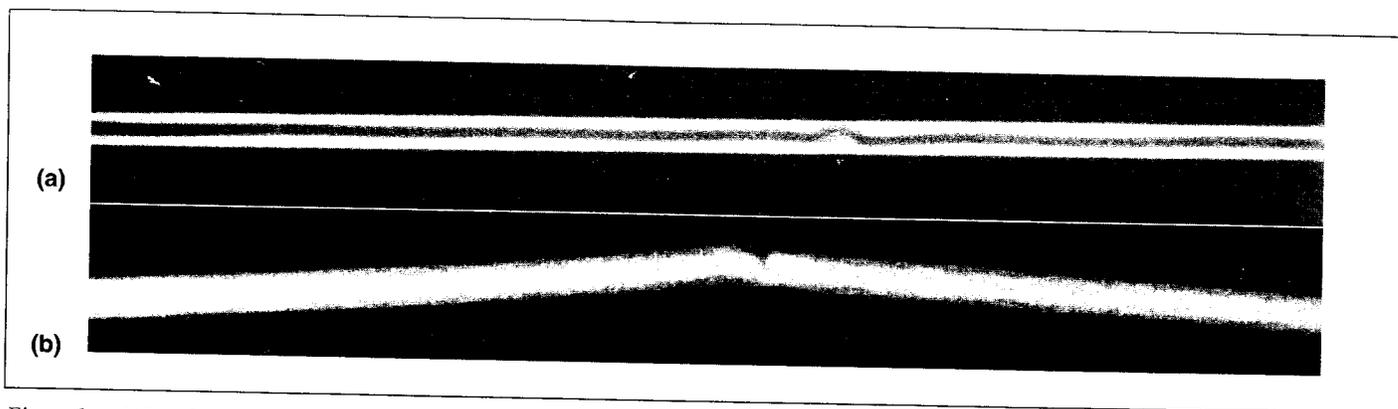
Figure 8 — Wires damaged by severe bending: (a) X-ray film detection; (b) X-ray charge coupled device detection.

A comparison of the results obtained by using the X-ray film detection and the X-ray charge coupled device detection modes is illustrated in the radiographs of Figure 8. Pulse X-rays were used to test two 18 gage aircraft wires that each suffered from cracked and embrittled insulation. The damage to the Figure 8a wire was incurred while being bent and snapped after having been submerged in liquid nitrogen, while the cracking in the Figure 8b wire was the consequence of severe, repetitive bending. The radiograph in Figure 8a was recorded on film by means of nine pulses from the pulsed source with the specimen set back 150 mm (6 in.) from the X-ray collimator cap. The twist in the copper wire is evidence that the conductor has undergone a significant deformation in the vicinity of the embrittlement. The pulse X-rays also provide critical information on the position of the conductor within the insulation. For instance, on the top side of the contortion there is considerably less

insulation than on the bottom side. The radiograph in Figure 8b was taken via the pulse X-ray charge coupled device array detection system and digitally recorded. A total of 10 X-ray pulses were fired at the specimen, which was positioned 250 mm (10 in.) back from the X-ray collimator cap. The penetrating power of the pulse X-rays permits a high resolution depiction of the individual strands of copper wire. Furthermore, the breach in the exterior insulation is also clearly discernible. Clearly, the film detection method provides substantially more detail regarding the thickness and external state of the insulation, whereas the charge coupled device detection method evidently provides more insight into the internal conditions of the wire conductor.

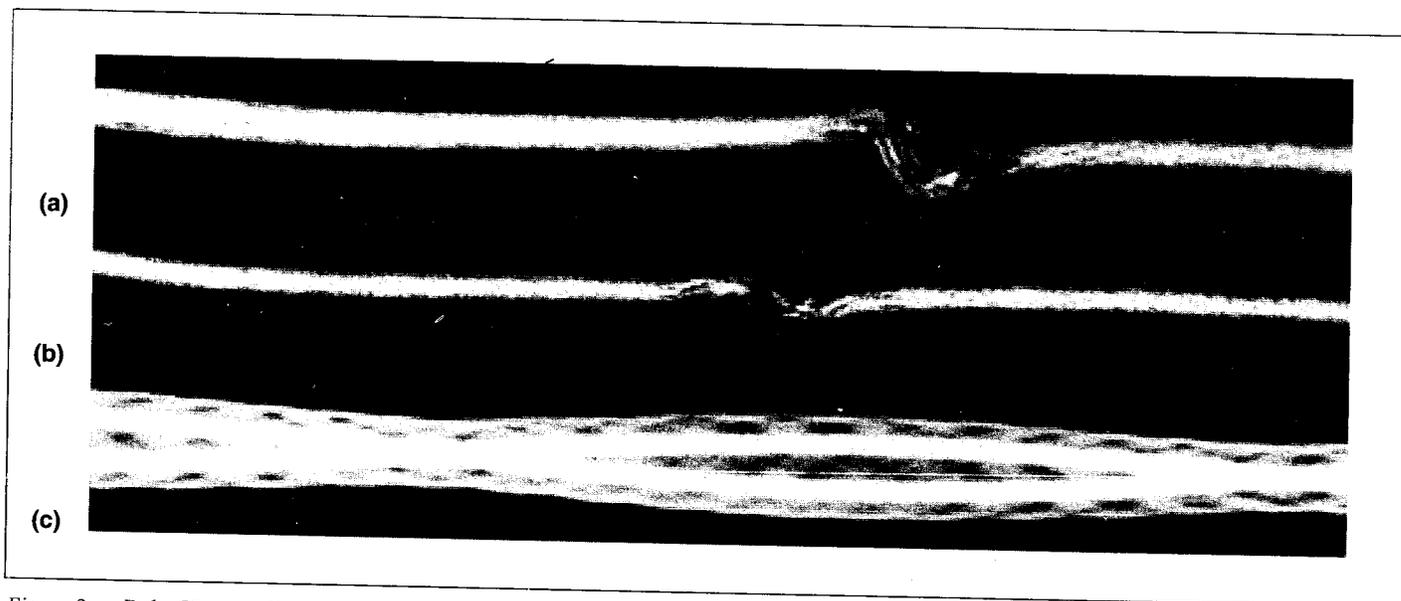
Figure 9 — Pulse X-ray radiographs: (a) burnt wire; (b) crimped wire; (c) undamaged metallic braided wire

All of the specimens shown in Figure 9 were dosed with 10 pulse X-rays and each of the specimens was set back 250 mm (10 in.) from the pulser. The pulse X-ray radiograph in Figure 9a is of a wire that had experienced extensive charring damage. The segment of wire featuring the dramatic kink corresponds directly with the extent of the scorched area. The brightness of the wire rapidly fades in this burnt section and is consistent with an observable decrease in the amount of insulation present in this portion of the wire. Moreover, upon closer examination of the radiograph, only a few spindly threads of conductor are visible, suggesting a possible degradation, or even loss, of copper wire in the damaged region. In Figure 9b, a wire that had been crimped was analyzed with pulse X-rays. Again, it is possible to demarcate the portion of the wire that has been impaired. Likewise, the individual strands of copper are also obvious; hence, a significant discontinuity in the conductor is clearly discernible in the contorted region that was crimped. Finally,

a prominent decrease in light intensity in the crimped region is indicative of a loss of insulation and possibly wiring. An undamaged metallic braided wire was studied using the pulse X-ray system as well, as depicted in Figure 9c. Not surprisingly, the two insulated copper conductors buried beneath the metallic braiding are easily identifiable. The imaging system also uncovers the presence of the actual interwoven metallic braiding pattern.
