Swimmer Safety Breakwater

Problem Statement

At Condado Beach in San Juan, PR, between Ventura Al Mar and Cervantes Street, hazardous rip currents and surf cause unsafe swimming conditions resulting in drownings.

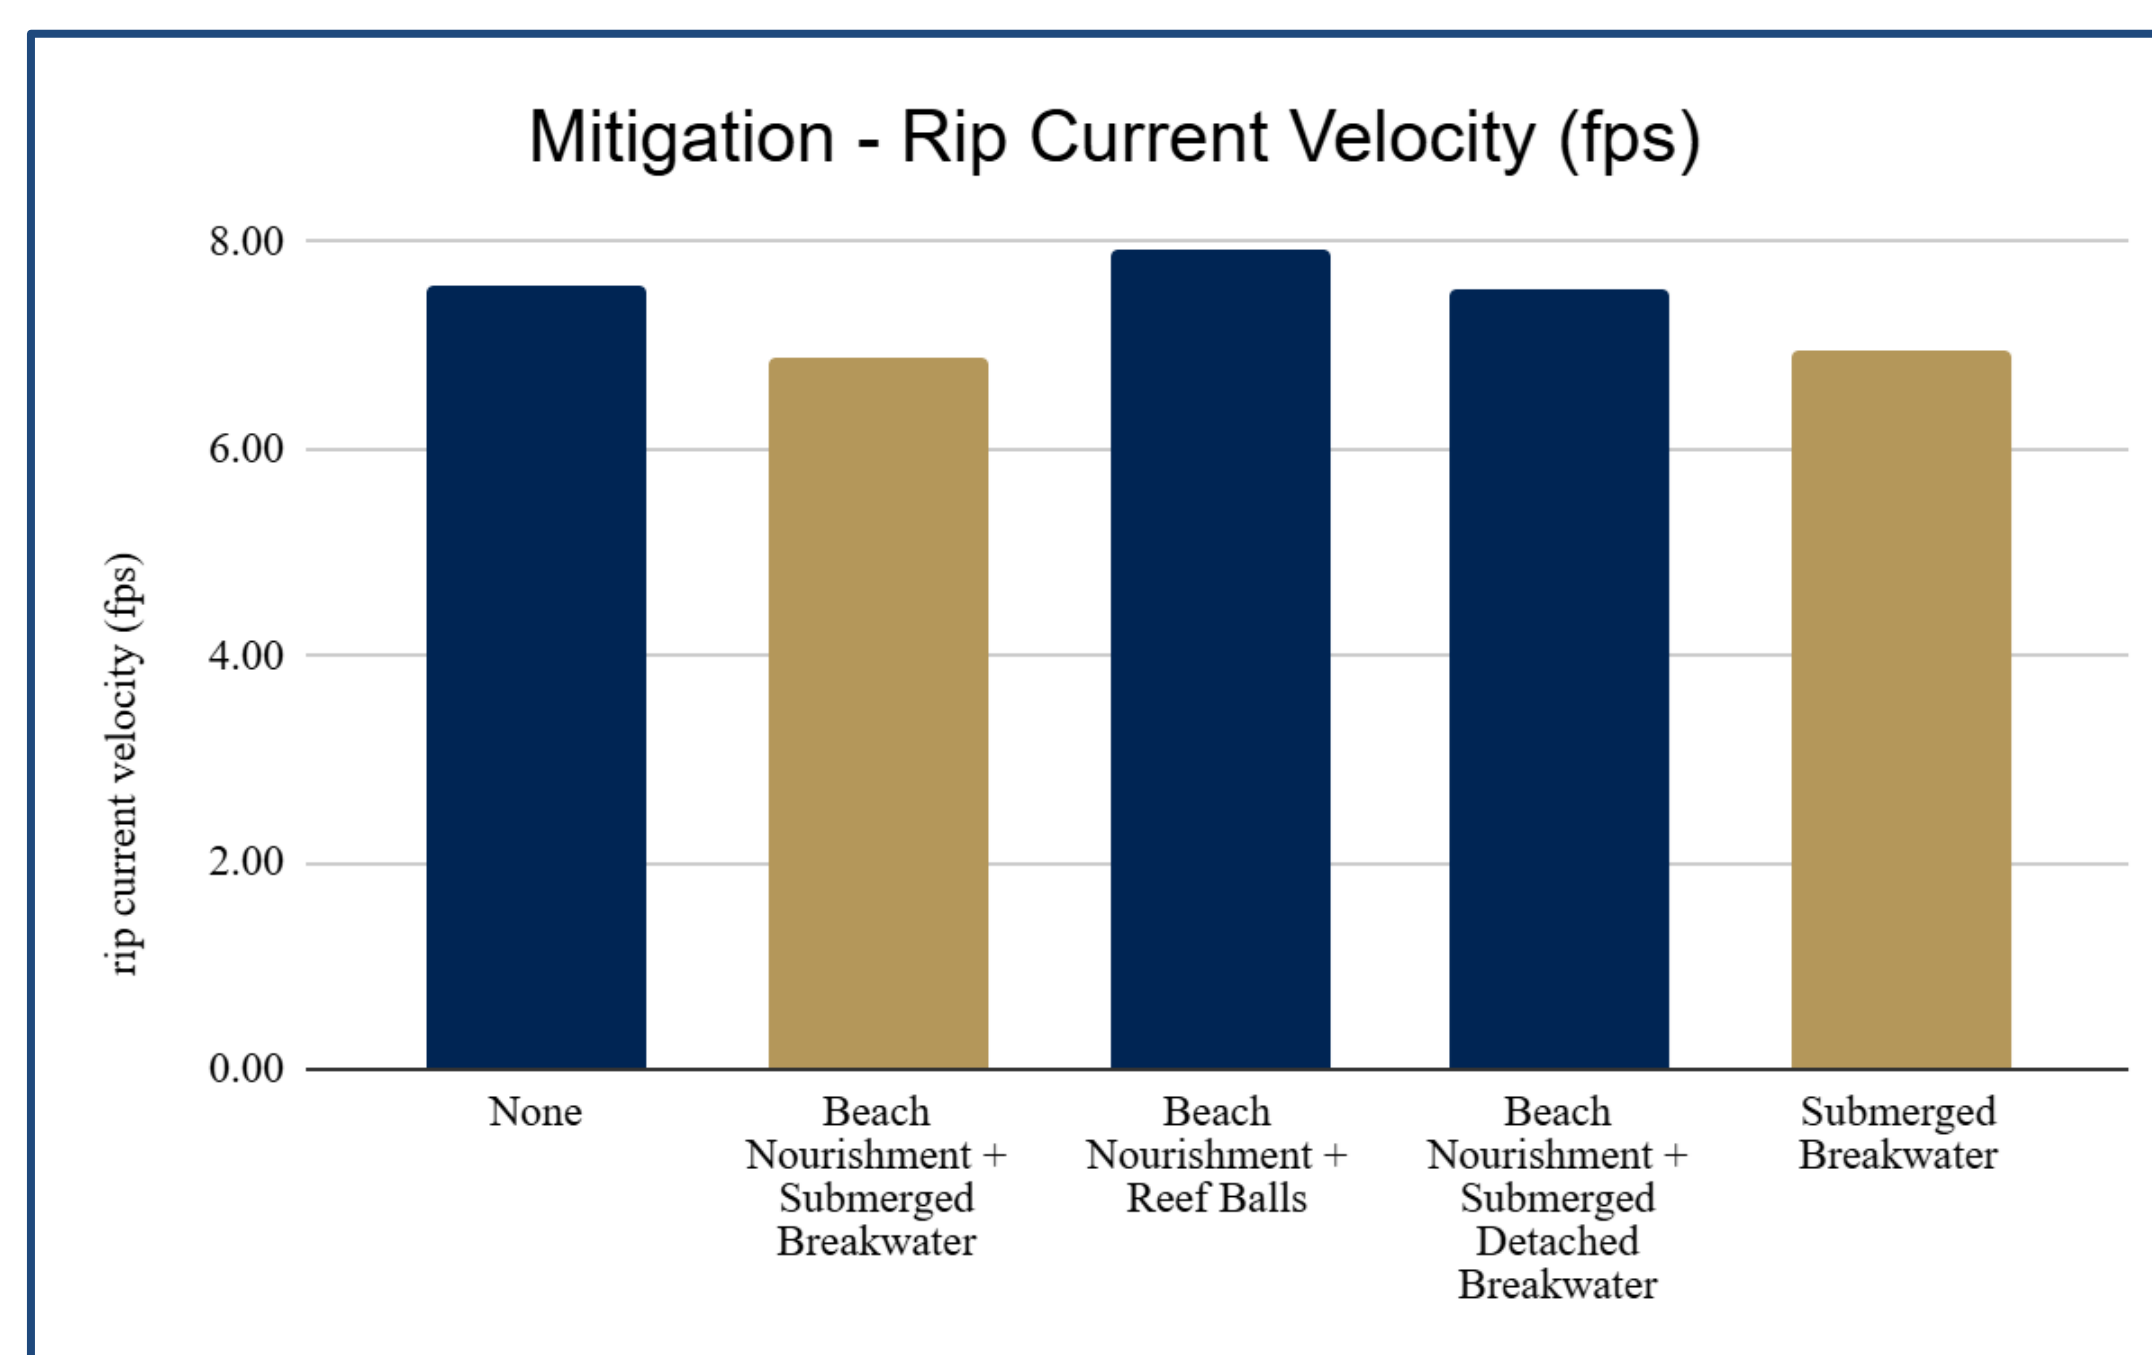
Rip Current Mitigation Testing Completed in USNA Coastal Basin - Results show actual wave conditions

Real World Conditions $\lambda = 61.35$	Rip Current (fps)	Shore Wave Height (ft)	Deep Wave Height (ft)
No Mitigation	7.57 ft/s	7.79 ft	14.78 ft
Submerged Breakwater	6.96 ft/s	6.62 ft	15.26 ft
Nourishment + Breakwater	6.90 ft/s	6.53 ft	14.57 ft

Table comparing top mitigation methods to baseline conditions

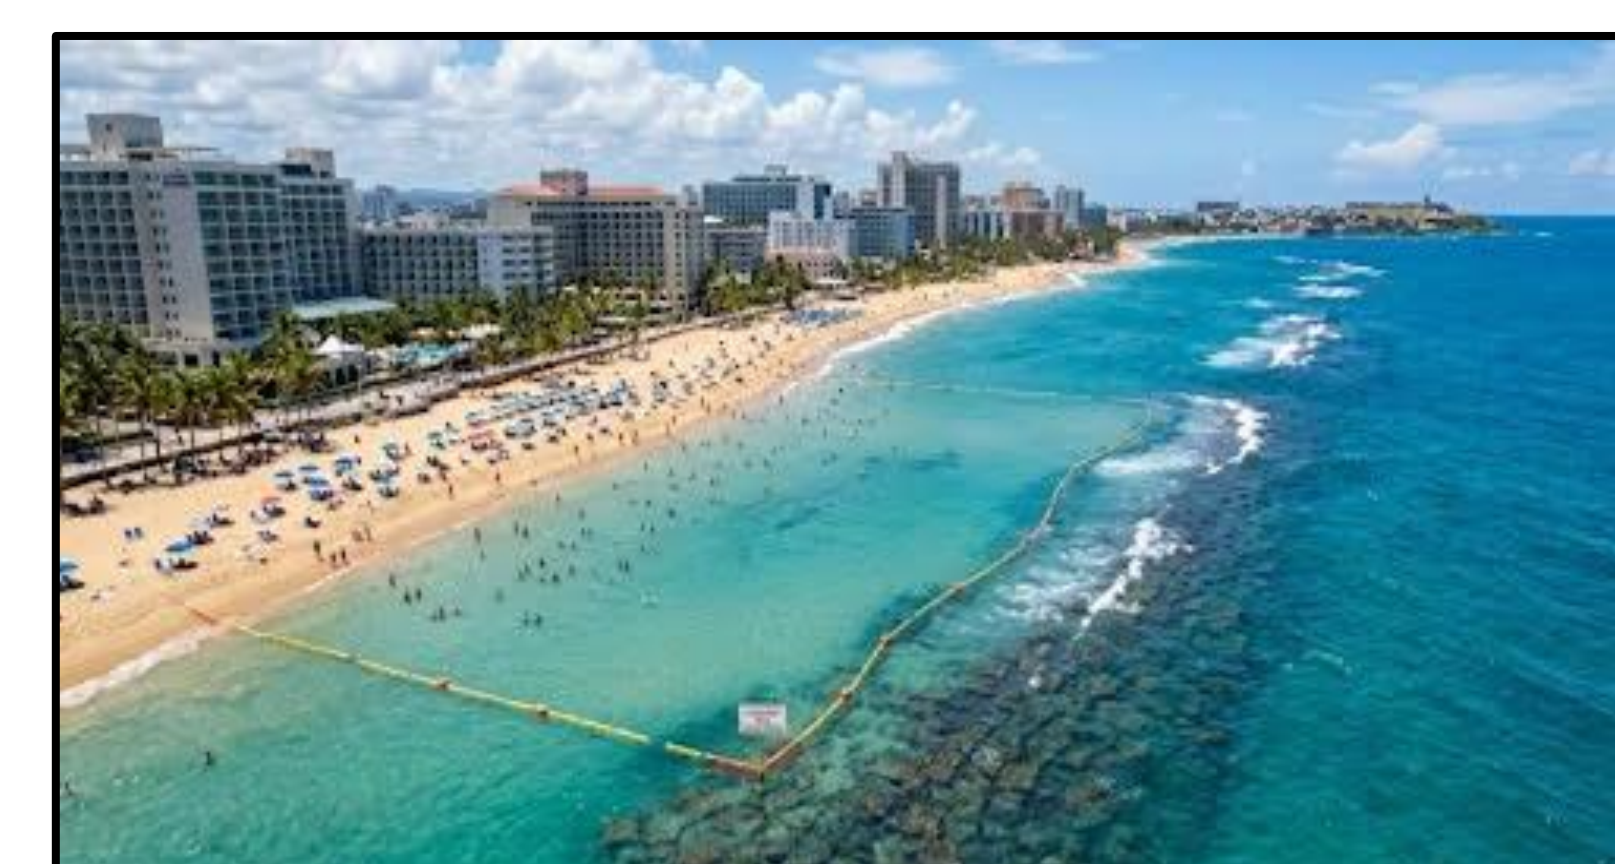
Gemini-Created Mockup of Submerged Breakwater at Condado Beach
